Manhole Inspection Summary

Manhole # S55S__005MH

Insp Date: **2/4/09 9:18 AM**

Location Address: **1655 S HIGHLAND ST**

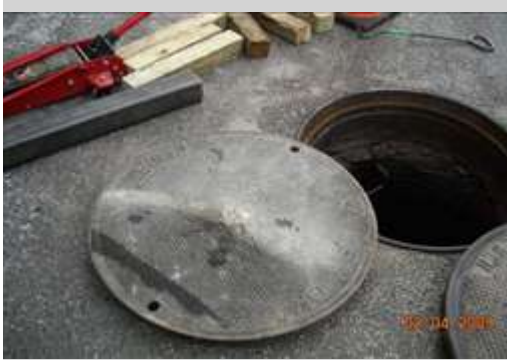
MISC.

REPLACED BROKEN COVER

Comments **USED HYDROLIC JACK TO FORCE OPEN. BROKE AND REPLACED COVER (see photos)**

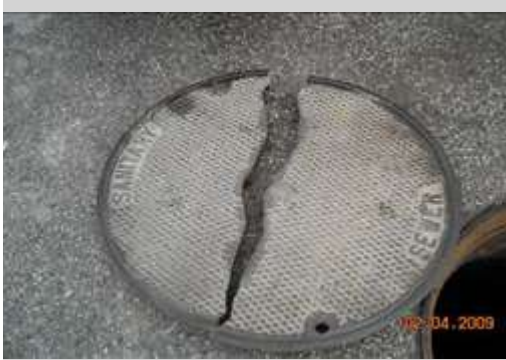
MISC.

BROKE COVER TO GAIN ACCESS

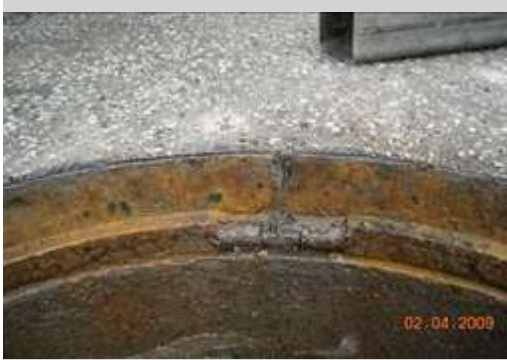
MISC.

FRAME ADJUSTMENT RING

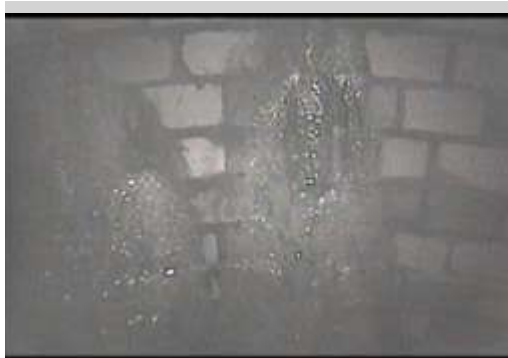
Defect 2

Infiltration: ☐ None ☐ Joint ☐ Cracks ☐ Mortar ☐ Roots ☒ **Wall**

INFILTRATION @ BARREL WALL

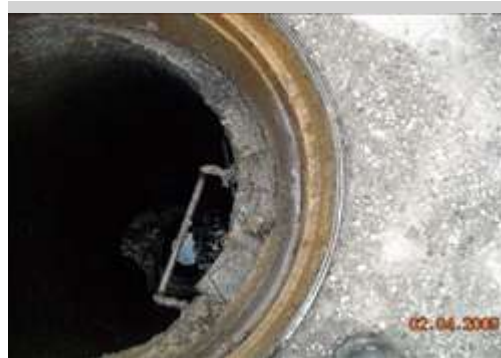
Defect 1

Offset: **3** (in.)

FRAME OFFSET

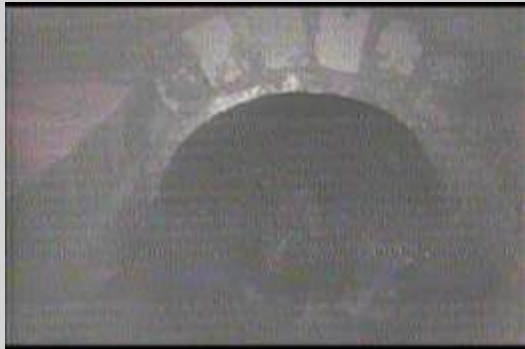
12 O'Clock Outflow

16 in. Circular Gravity Sewer
Pipe Out @ 12 O'Clock

Pipe Height: **16.8** (in.) Rod and Bar (Angled)
Pipe Material: **Unknown** ☐ Pipe Lined
Invert Depth: **18.15** (ft.) Flow Characteristics: **None**
Deposits: ☒ None ☐ Mud ☐ Sludge ☐ Debris ☐ Grease
Silt Depth: **0** (in.) Deposits Extent:
Infiltration: **None** Pipe Seal Cond: **Sound**

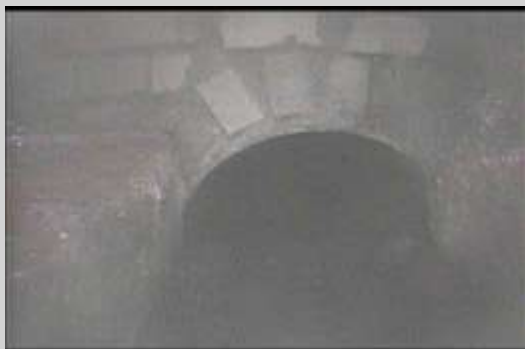
6 O'Clock Inflow

16 in. Circular Gravity Sewer
Pipe In @ 6 O'Clock

Pipe Height: **16.8** (in.) Rod and Bar (Angled)
Pipe Material: **Unknown** ☐ Pipe Lined
Invert Depth: **18.05** (ft.) Flow Characteristics: **Slow**
Deposits: ☒ None ☐ Mud ☐ Sludge ☐ Debris ☐ Grease
Silt Depth: **0** (in.) Deposits Extent:
Infiltration: **None** Pipe Seal Cond: **Sound**
